# Safe storage of wood pellet and wood chip fuel

Prepared by the Health and Safety Executive

**RR1077**

Research Report

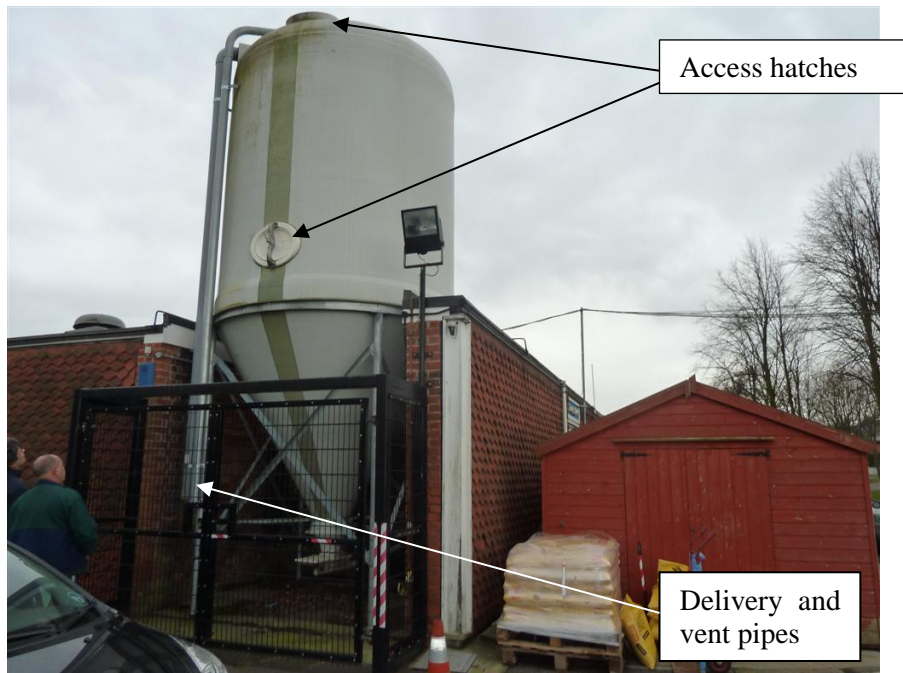
**Photograph 1** Site 1 pellet storage silo

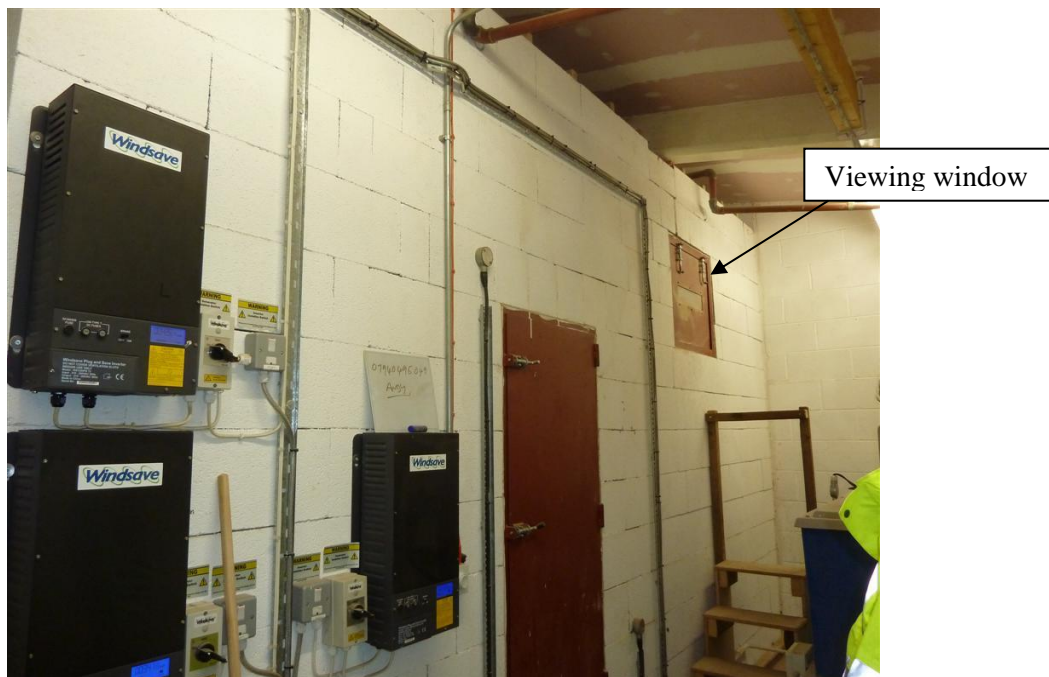
**Photograph 2** Site 2 wood pellet store

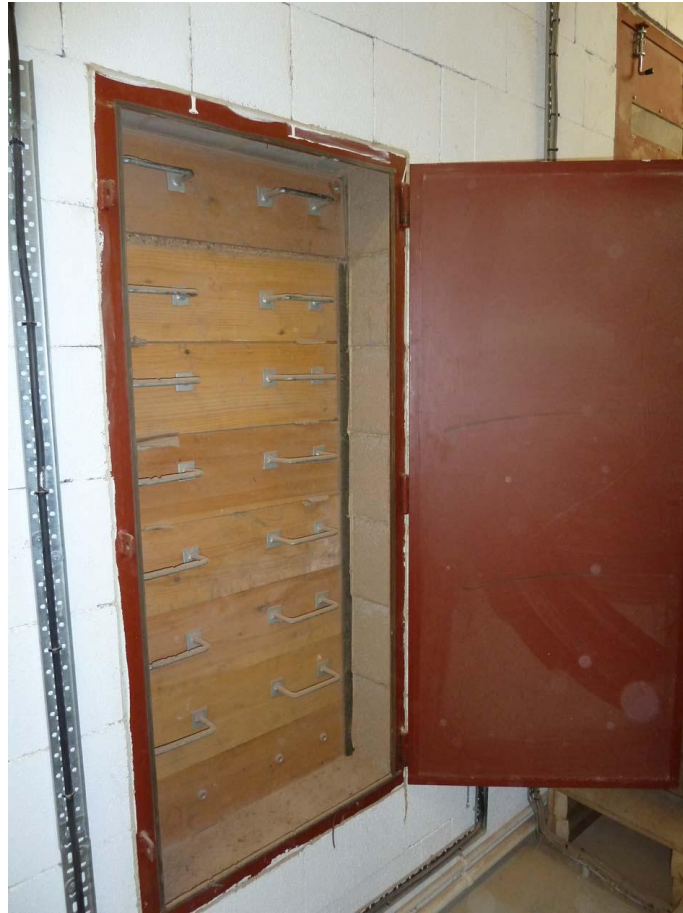
**Photograph 3** Site 2 open access door to the pellet store

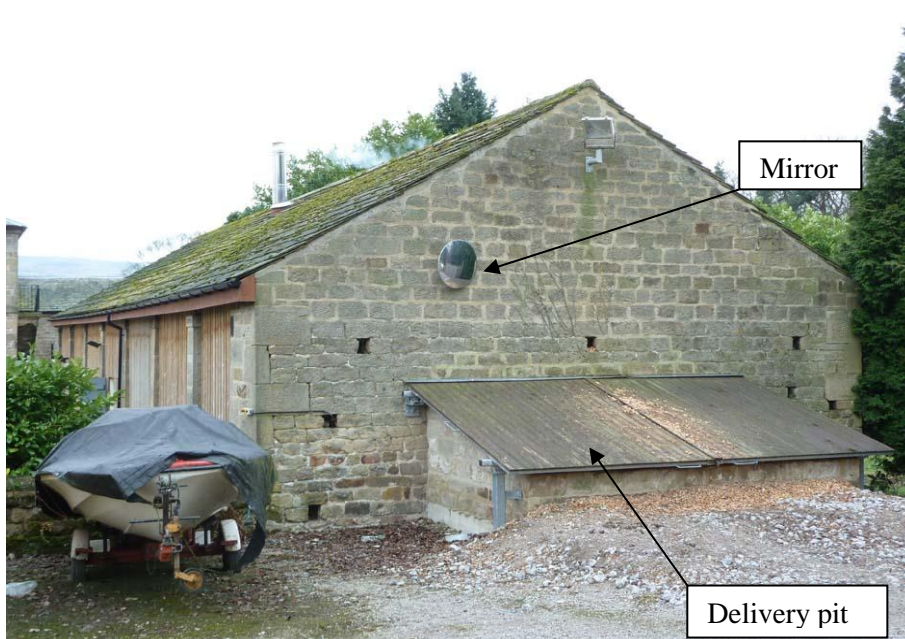
**Photograph 4** Site 3 boiler house and wood chip delivery pit

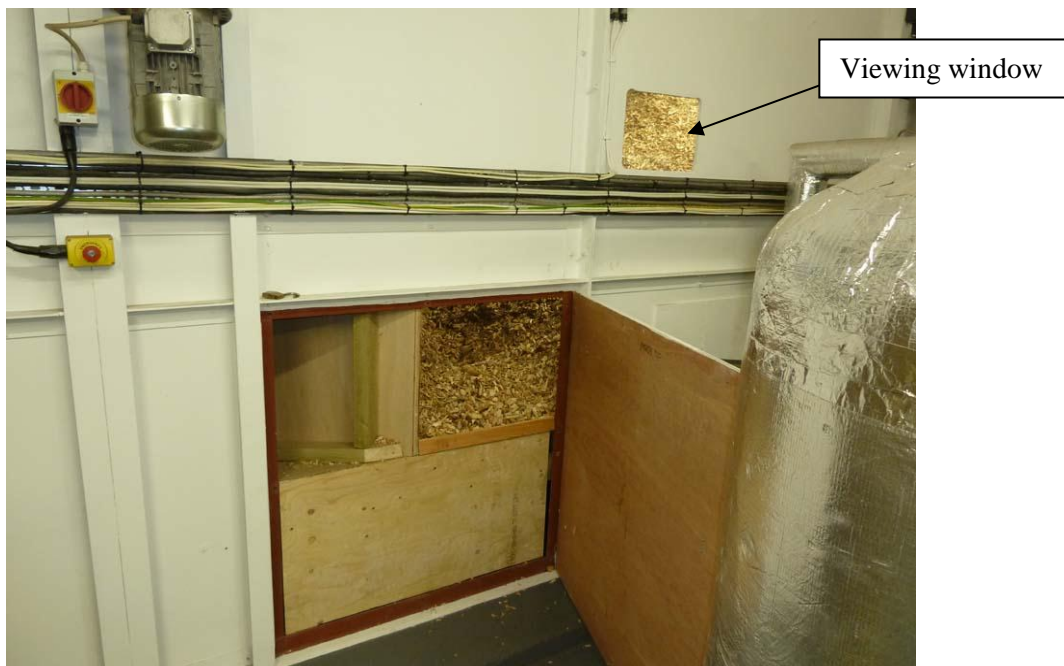
**Photograph 5** Site 3 wood chip store access hatch in the boiler room

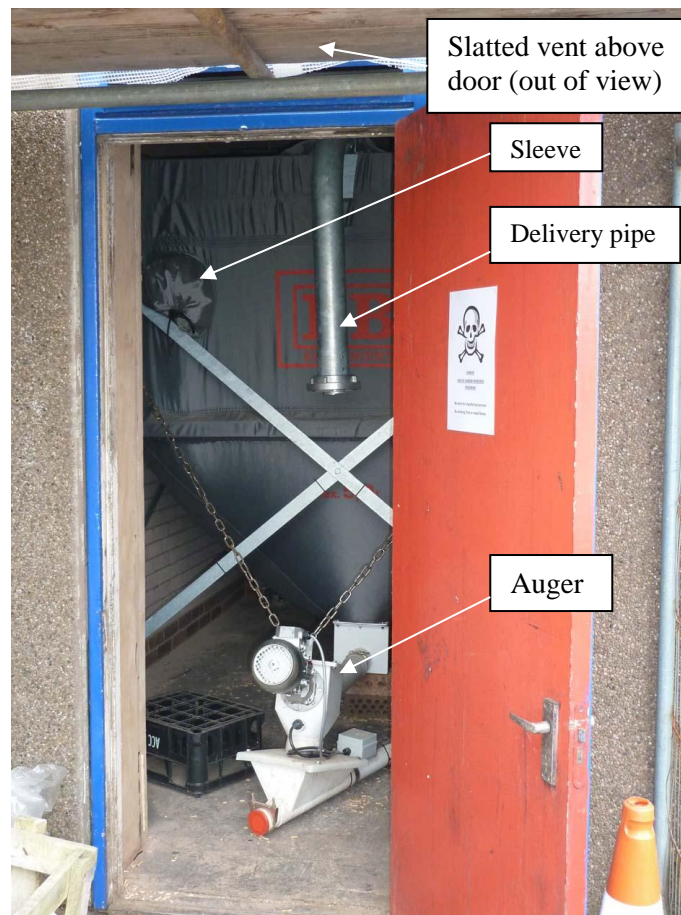
**Photograph 6** Site 4 fabric silo in the wood pellet store room

As noted earlier, there was no exhaust pipe on the Site 4 silo, resulting in the incoming air escaping through the fabric of the silo. The fabric presumably filters out much of the coarse airborne dust.

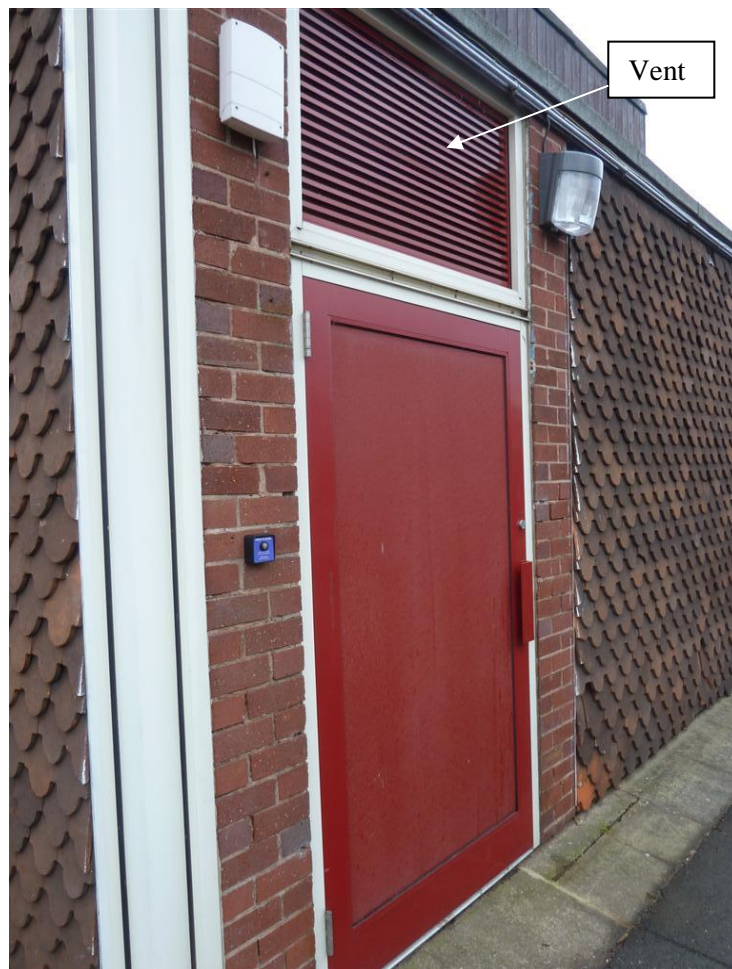
**Photograph 7** Site 5 wood pellet store

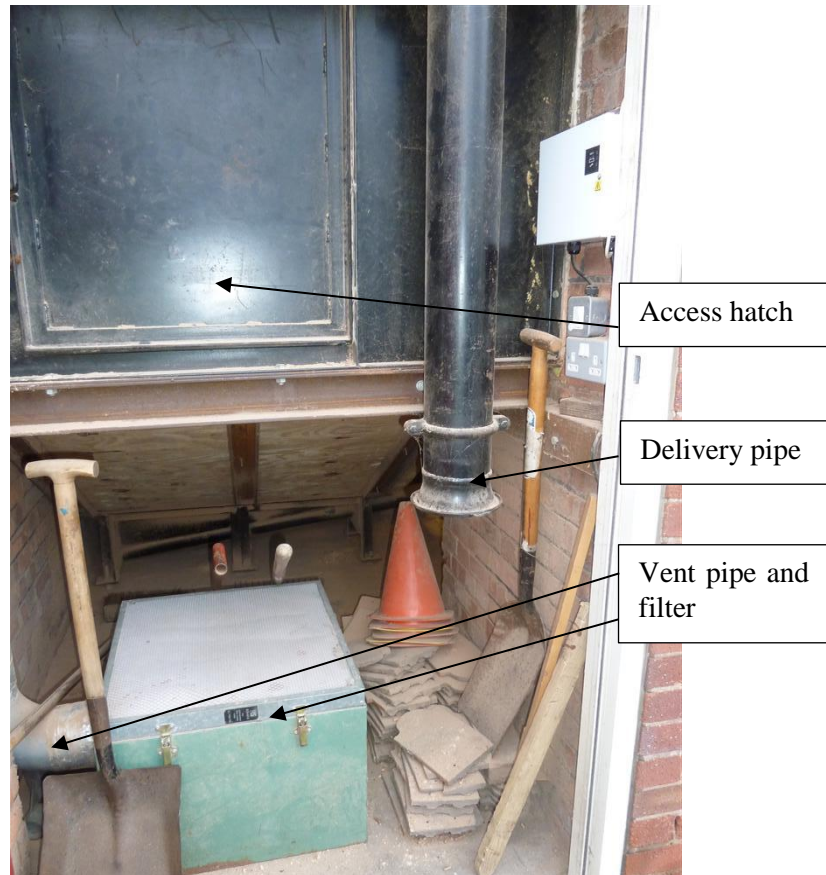
**Photograph 8** Site 5 pellet store entrance

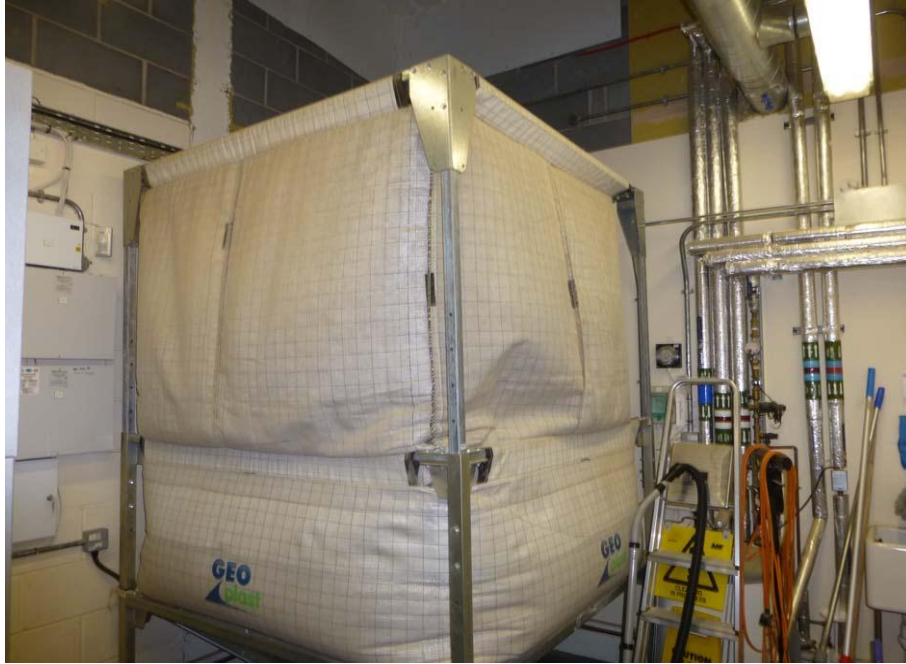
**Photograph 9** Site 6 wood pellet storage silo in the boiler room

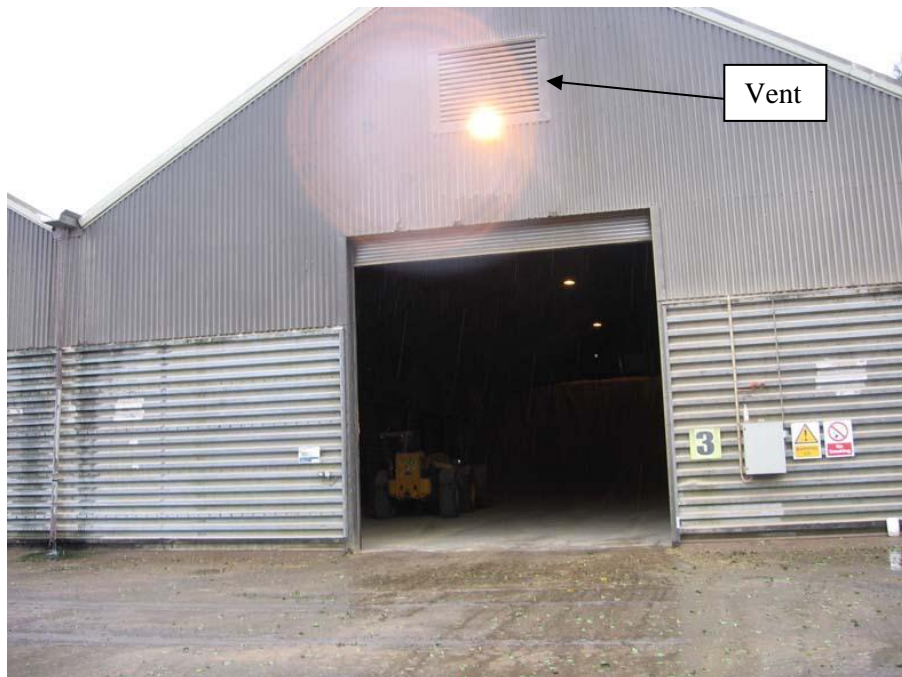
**Photograph 10** Site 7 wood pellet storage facility

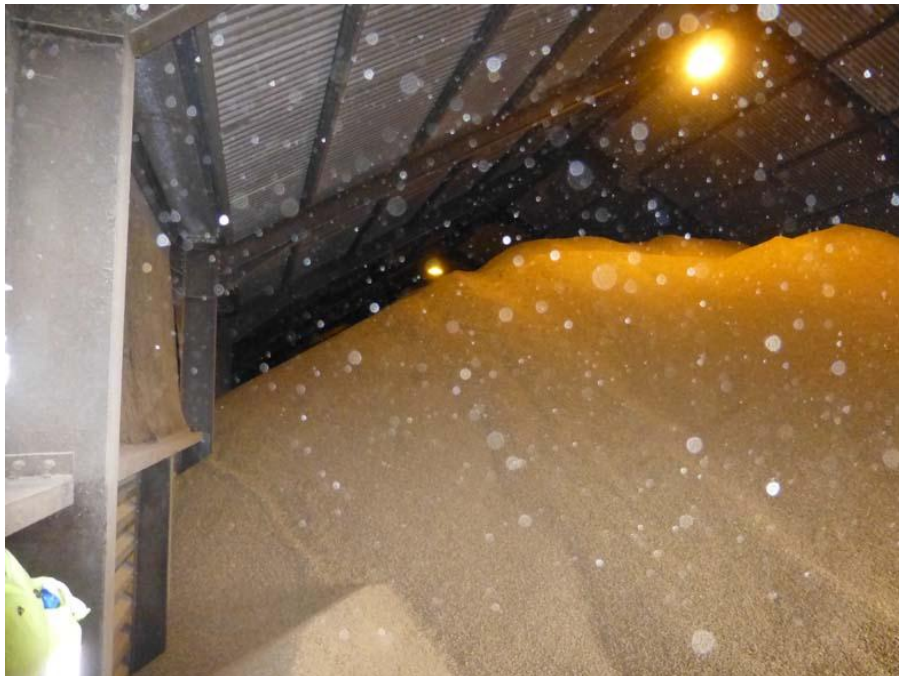
**Photograph 11** Inside Site 7 wood pellet storage facility

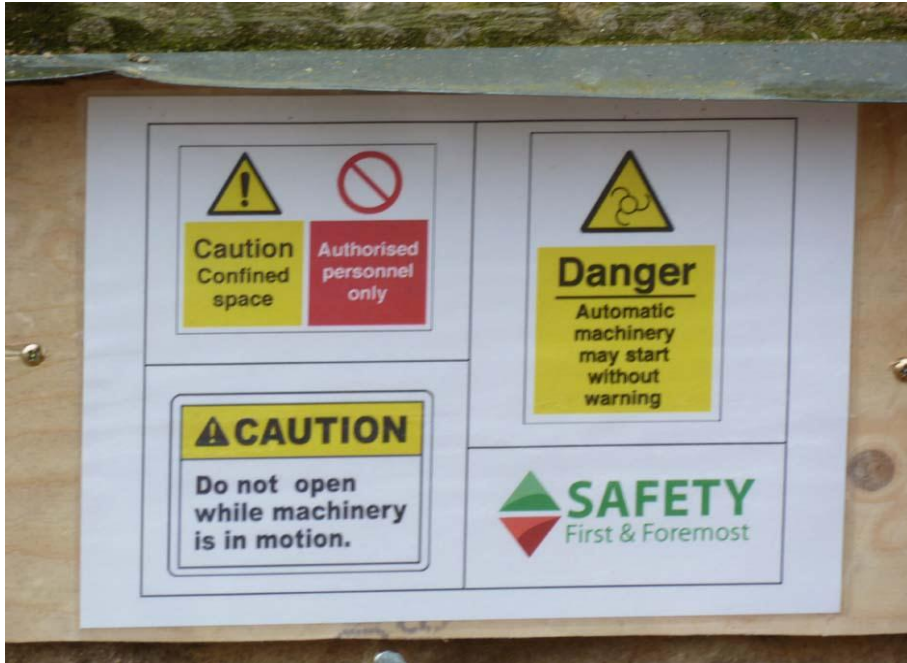
At Site 3 there were commercially produced warning signs on the outside of the store room hatch door and above the tipping pit warning that the store is considered a confined space, authorised personnel only are permitted, and that there is a potential hazard from moving machinery. There was no warning of possible carbon monoxide or depleted oxygen hazards, and when the hatch door is open the sign is not visible. Although the warning sign said that the wood store was a confined space, this was not reflected in company procedures or training.

**Photograph 12** Site 3 warning notice by tipping pit – identical to notice on internal hatch door

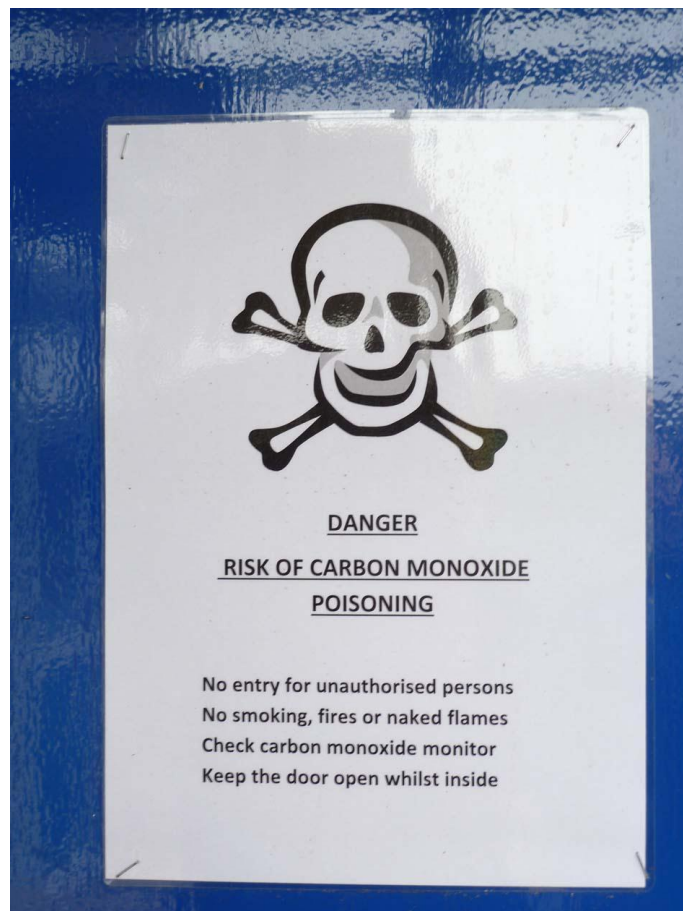
**Photograph 13** Warning sign present on both sides of Site 4 store room door

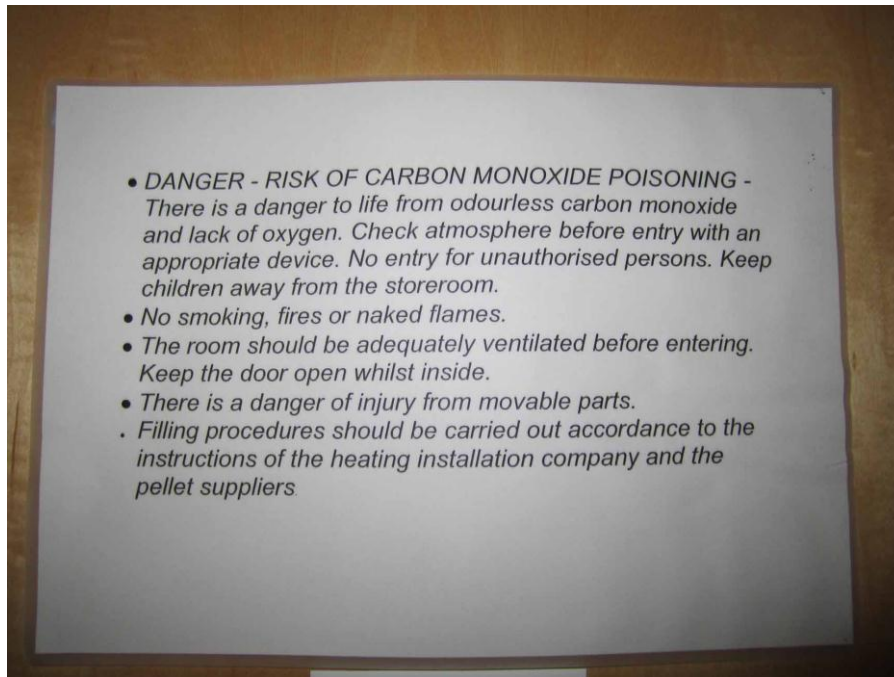
The door to the Site 6 boiler room had a notice on both sides and used the information recommended on the HSE Safety Notice. This covered: the risk of carbon monoxide poisoning and lack of oxygen; no entry for unauthorised persons; no smoking, fires or naked flames; ventilating the room adequately before entering; keeping the door open whilst inside; and danger from moving parts.

**Photograph 14** Site 6 warning notice present on both sides of the store room door (text taken from the HSE Safety Notice)
