# Safe storage of wood pellet and wood chip fuel

Prepared by the Health and Safety Executive

**RR1077**

Research Report

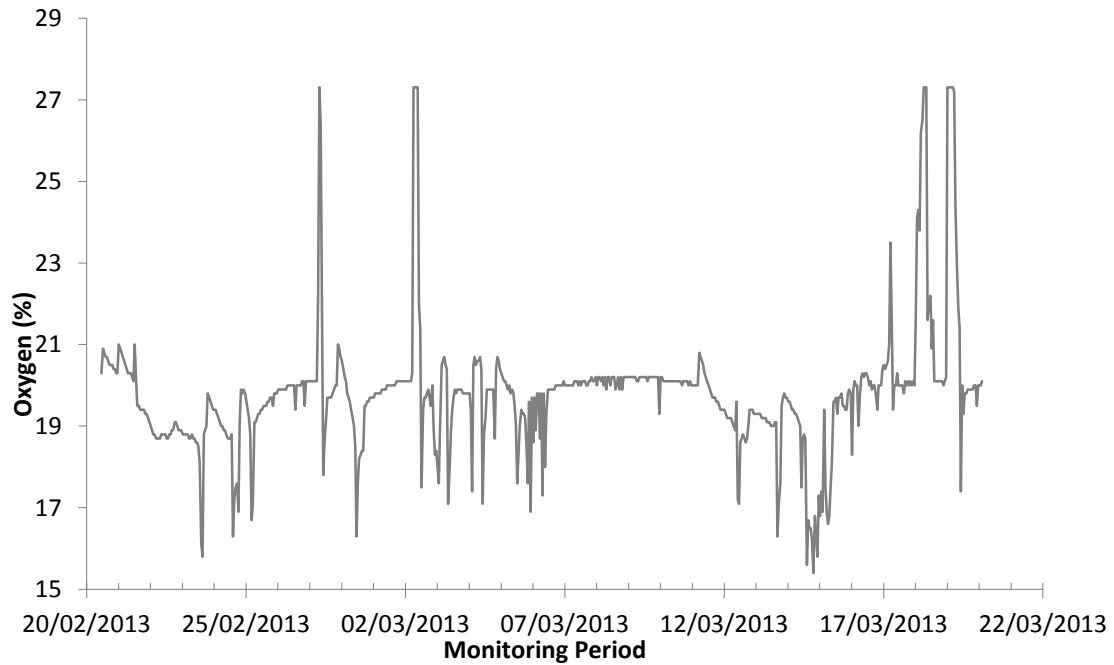
**Figure 2** Site 3 wood chip store oxygen concentrations

The GasClam monitor oxygen results presented some problems in interpretation. The oxygen levels at Sites 2, 6 and 7 were similar to those in ambient air, but those at Sites 3 and 4 were more varied (Figures 2 and 3).

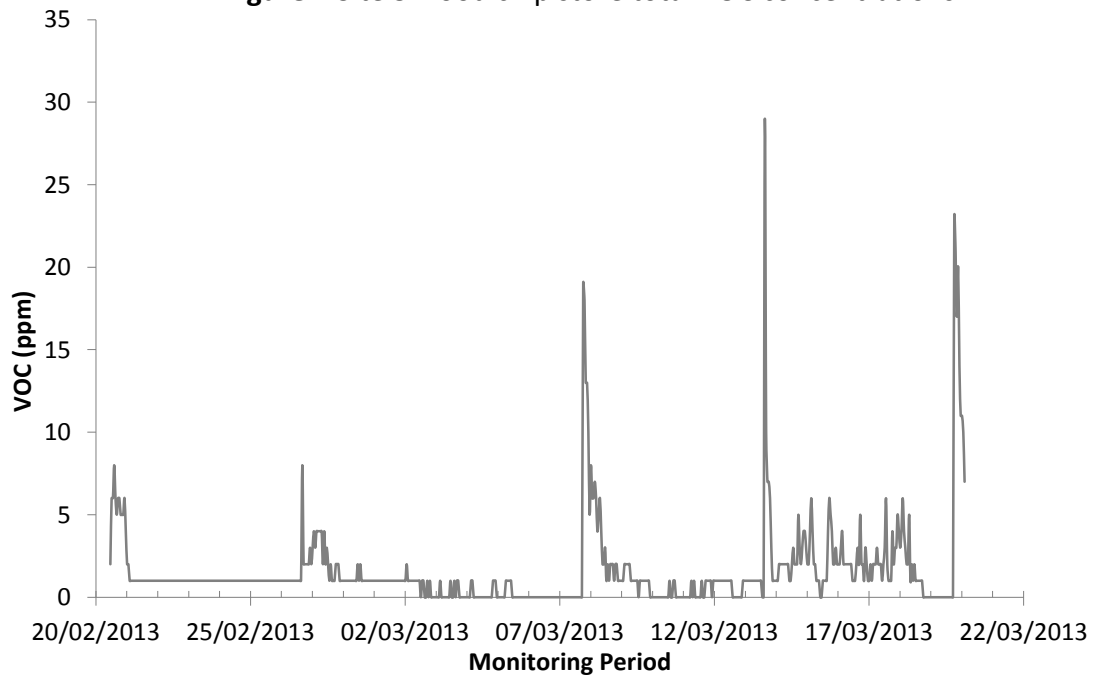
**Figure 4** Site 3 wood chip store total VOC concentrations

The GasClam at Site 3 detected peak VOC concentrations in the wood store on dates coincident with wood store activity (20/2/13, 26/2/13, 7/3/13, 13/3/13 and 19/3/13, from Table 1, Appendix A) (Figure 4). There was no corresponding peak on 15/3/13. Peak concentrations of up to 29 ppm total VOC were detected; however, these were relatively short lived peaks, typically lasting less than one day.

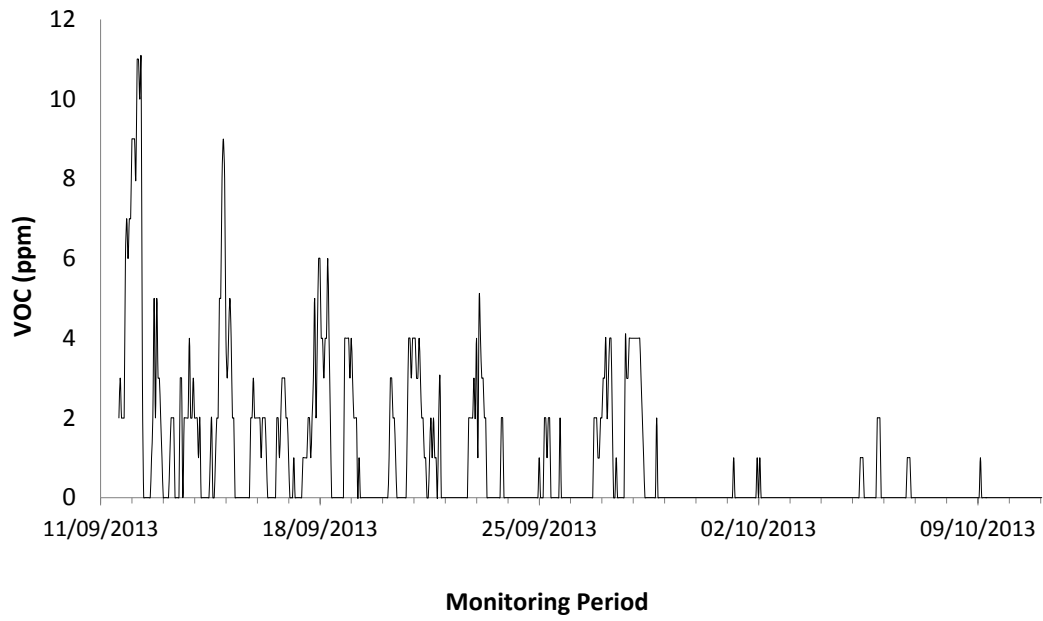
**Figure 5** Site 7 wood pellet store  
total VOC concentrations

The VOC data from Site 7 are also presented graphically in Figure 5; however no contextual evidence was recorded e.g. on days when the store was ventilated. Peak concentrations up to 11 ppm total VOC were detected and these were similarly short lived.

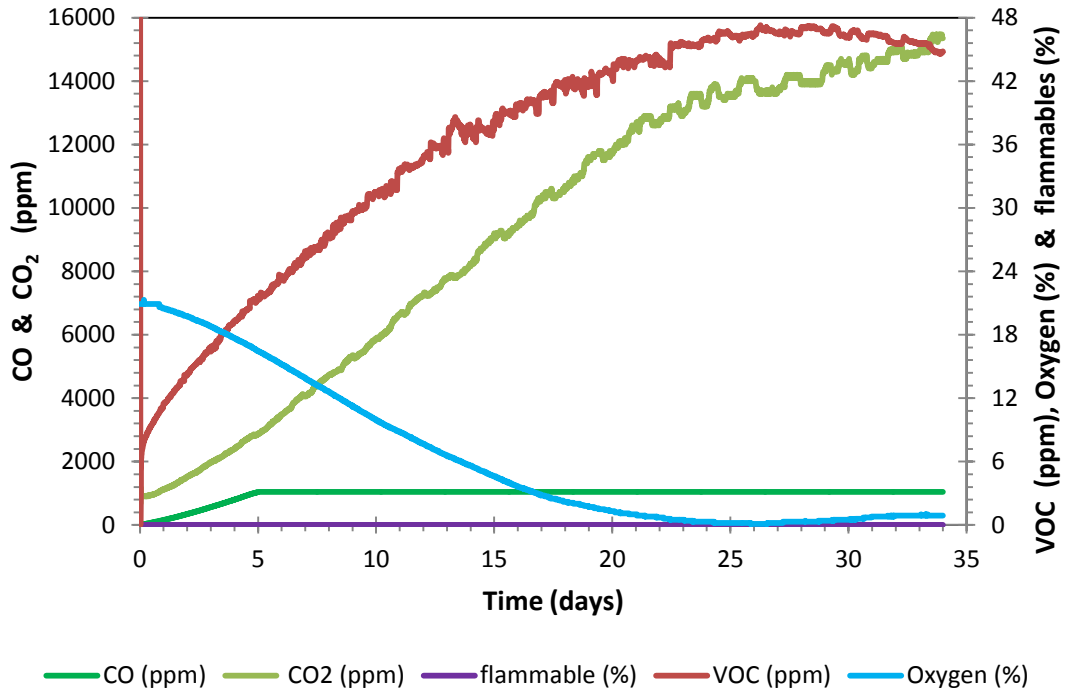
**Figure 6** Laboratory monitoring of air composition above wood pellets

The gaseous emissions from the wood pellets (Figure 6) showed the oxygen concentration falling to a minimum of 0.1% and the VOC concentration increasing to a maximum of 47 ppm after 26 days. The carbon dioxide concentration increased and reached 1,500 ppm by the end of the test. The carbon monoxide concentration steadily increased to 1042 ppm after 5 days when it appeared to reach the sensor's maximum range even though this is specified as 1500 ppm by the manufacturer. The flammable sensor did not show any response.

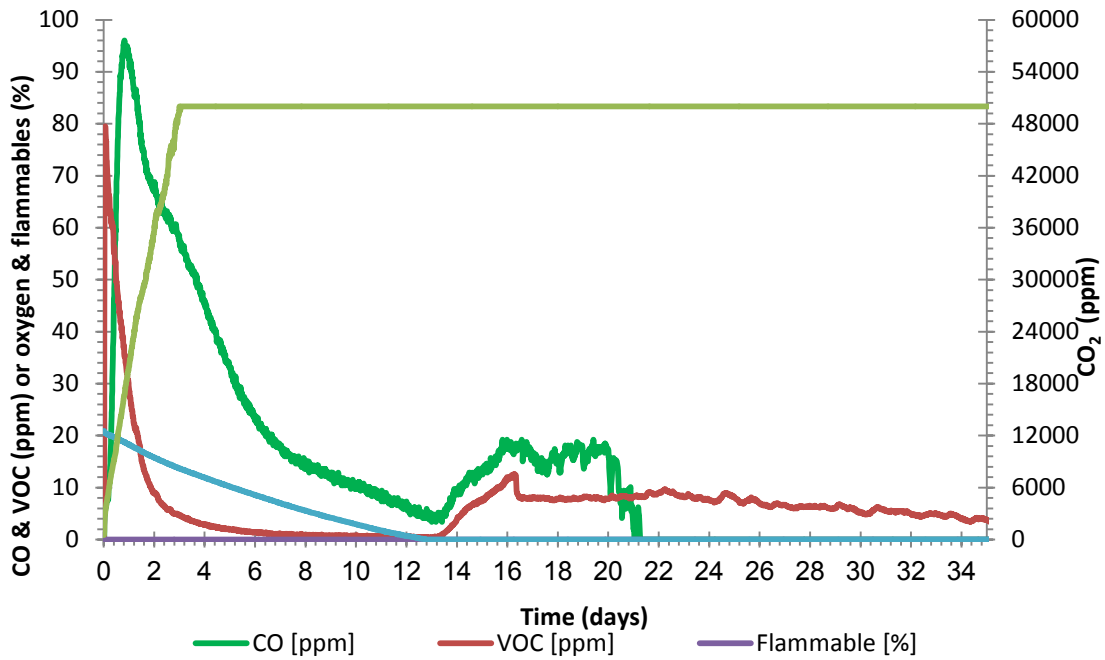
**Figure 7** Laboratory monitoring of air composition above wood chip

The gaseous emissions in the initial wood chip test were more complicated (Figure 7). The oxygen concentration fell to zero after 13 days. The carbon dioxide concentration quickly increased beyond the sensor's maximum value of 50,000 ppm after 3 days and the flammable sensor did not show any response. However, the carbon monoxide concentration rapidly increased to 96 ppm after 20 hours before falling to less than 10 ppm after 13 days. The VOC concentration increased to 80 ppm in 1.5 hours before similarly falling to less than 1 ppm again after 13 days. After 19 days it was noticed that the MultiRae monitor pump had failed and was operating in diffusion mode i.e. with a slower response time.

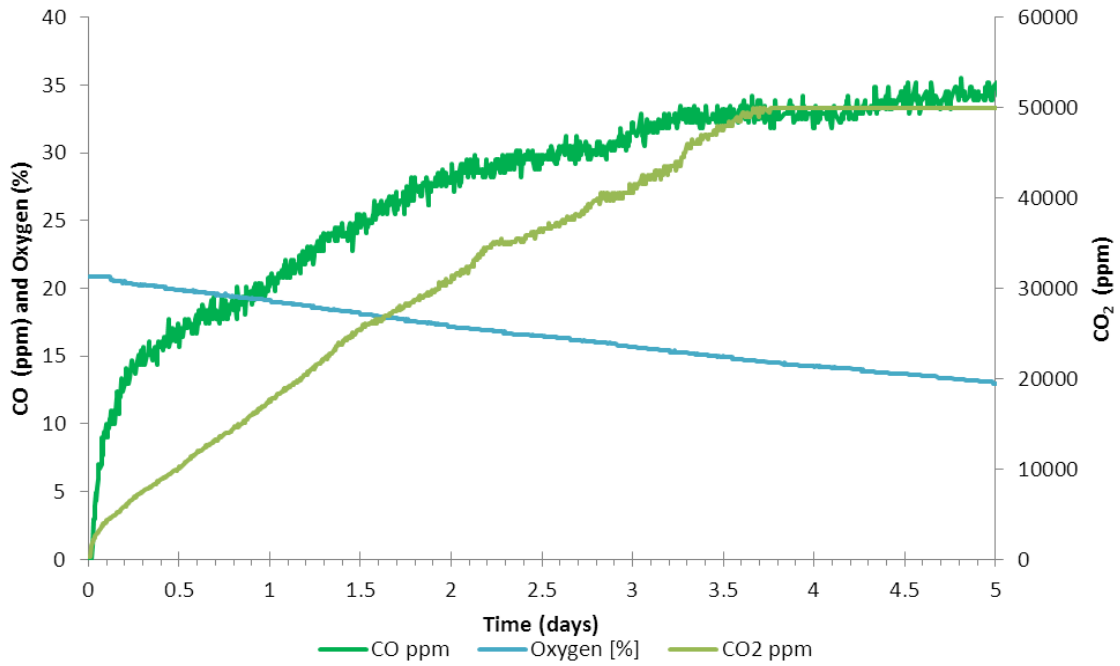
**Figure 8** Resumption of monitoring of air composition above wood chip

Subsequent testing of the monitors revealed that both carbon monoxide sensors were faulty and were indicating negative concentrations even when exposed to high concentrations of carbon monoxide. All sensors worked correctly after the monitors were left to stabilise for two days. Additional tests were conducted on the carbon monoxide sensor, exposing it to gas mixtures of carbon monoxide with high carbon dioxide or reduced oxygen, and it behaved as expected. The monitor was placed back into the wood chip drum 20 days after the original test was completed for a further five days: the carbon dioxide and oxygen concentrations behaved in a similar manner as before, the VOC and flammable concentrations showed no response, and the carbon monoxide concentration steadily increased to around 35 ppm (see Figure 8).

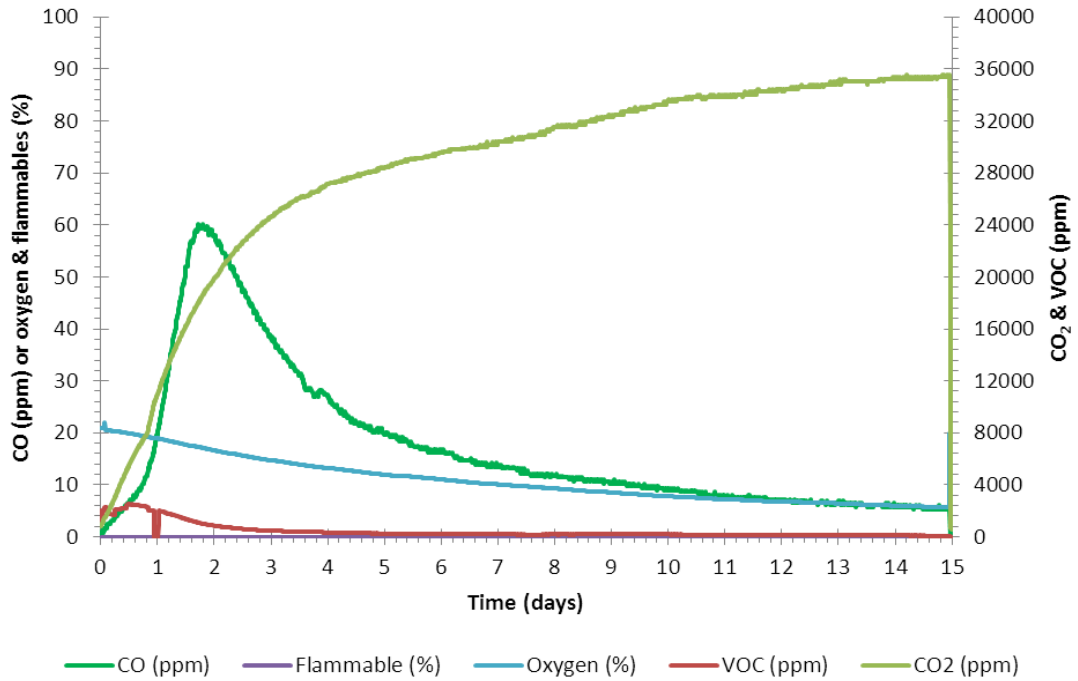
**Figure 9** Laboratory monitoring of air composition above undried wood chip

In the second series of tests, the undried wood chips (Figure 9) show carbon monoxide, carbon dioxide and oxygen concentrations following a similar trend as the initial test (Figure 7) except the concentrations were not as extreme. However, the VOC concentration peaked at 2450 ppm after about 12 hours which was approximately two orders of magnitude greater than measured on the initial test. The measurements of carbon monoxide, carbon dioxide and VOC concentration taken by the Gasmeter FTIR confirmed the measurements made with the MultiRae.

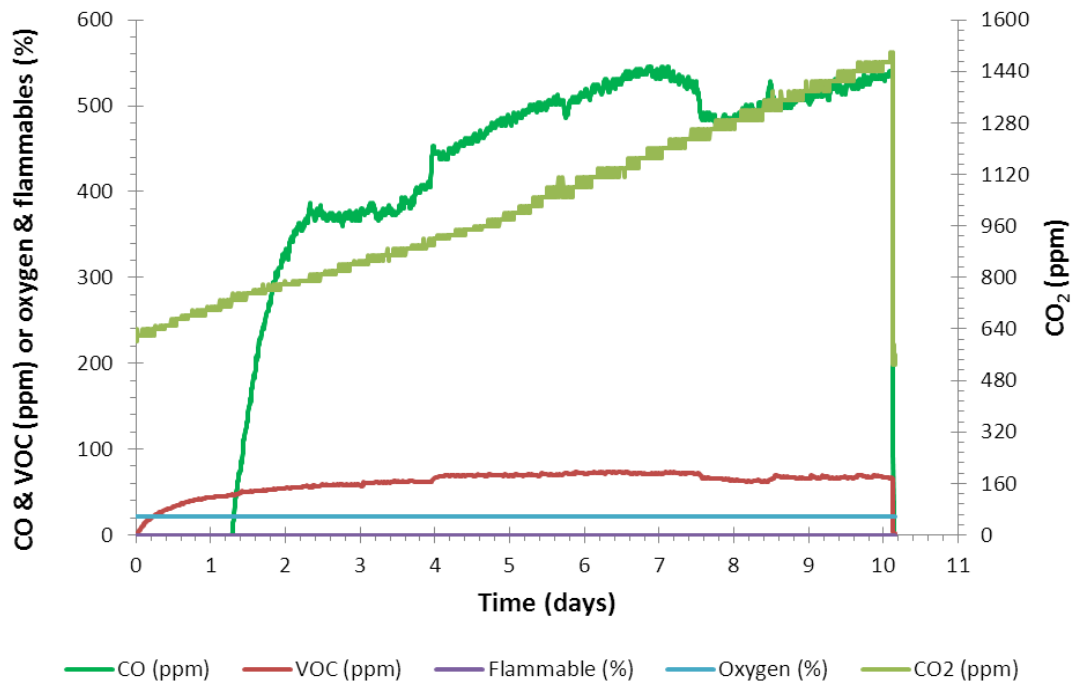
**Figure 10** Laboratory monitoring of air composition above dried wood chip

The dried wood chip emissions (Figure 10) followed a different pattern from the undried wood chip. The carbon dioxide steadily increased from 620 ppm to 1500 ppm, VOCs increased to around 70 ppm, and the oxygen concentration remained at 20.9%. The carbon monoxide concentration did not start to increase until the second day when it increased rapidly to about 380 ppm, followed by a less rapid rise to approximately 530 ppm.
